中文題目:金屬主動脈瓣膜之心內膜炎併發瓣膜周圍漏、環狀膿腫和假性動脈瘤

英文題目: Infective Endocarditis of Prosthetic Aortic Valve Complicated with Ring Abscess, Paravalvular Leakage and Pseudoaneurysm

作者: 陳則璋¹, 李政翰²

服務單位: 成大醫院內科部¹; 成大醫院內科部心臟內科²

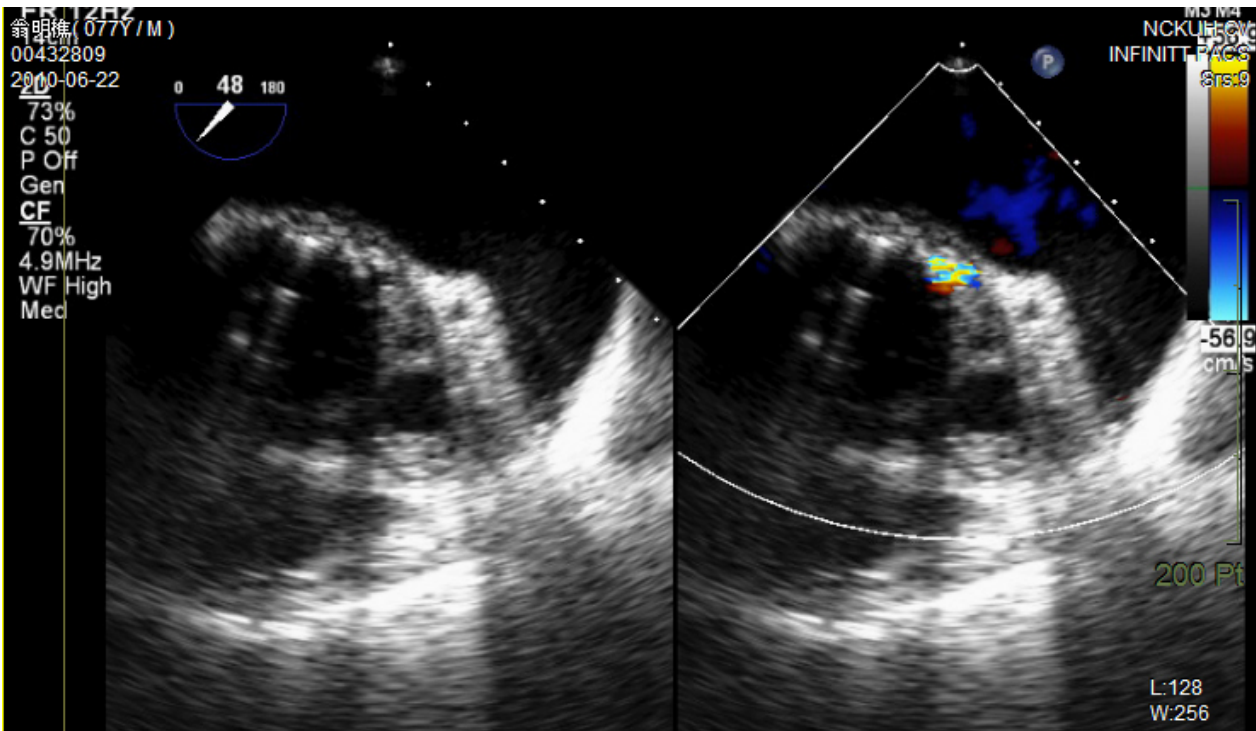
Figure 1 Transesophageal echocardiography showed a crescent echo-free space around the aortic ring (Figure 1A) and moderate severity of perivalvular regurgitation flow.

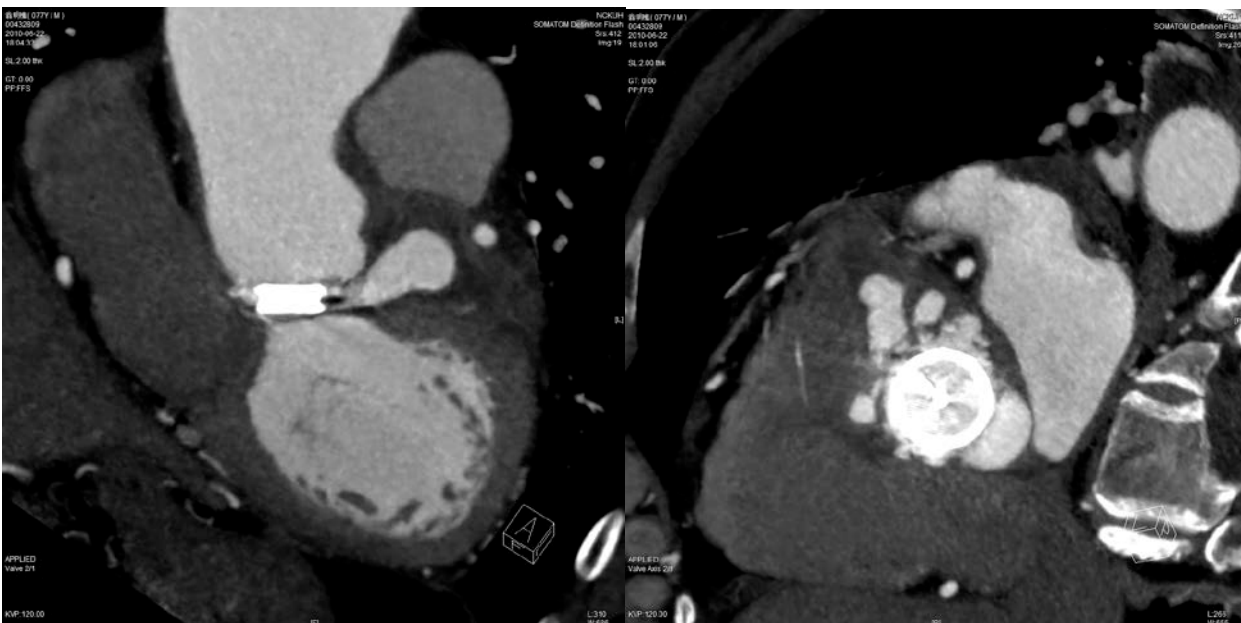
Figure 2. Dual-source dual-energy computed tomography demonstrated partial loose sutures of mechanical aortic valve, multifocal pseudoaneurysm formation and periaortic abscess formation.

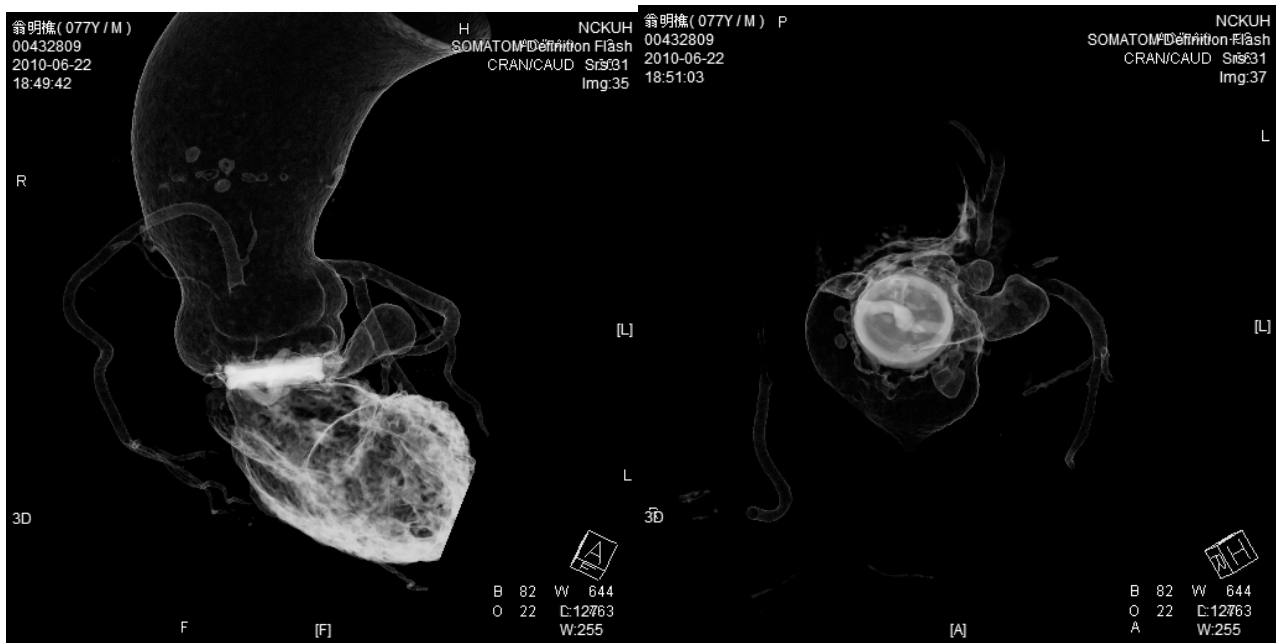
Figure 3. 3D reconstruction and post-processing of the computed tomography showed clearly the anatomy of the mechanical aortic valve, ring abscess, and pseudoaneurym.
